ASIA **TURBOMACHINERY** & **PUMP** SYMPOSIUM
MARCH 2018 | SUNTEC SINGAPORE

Investigation and Resolution of Governing Valve Linkage Failure for Compressor Drive Steam Turbine

Abstract

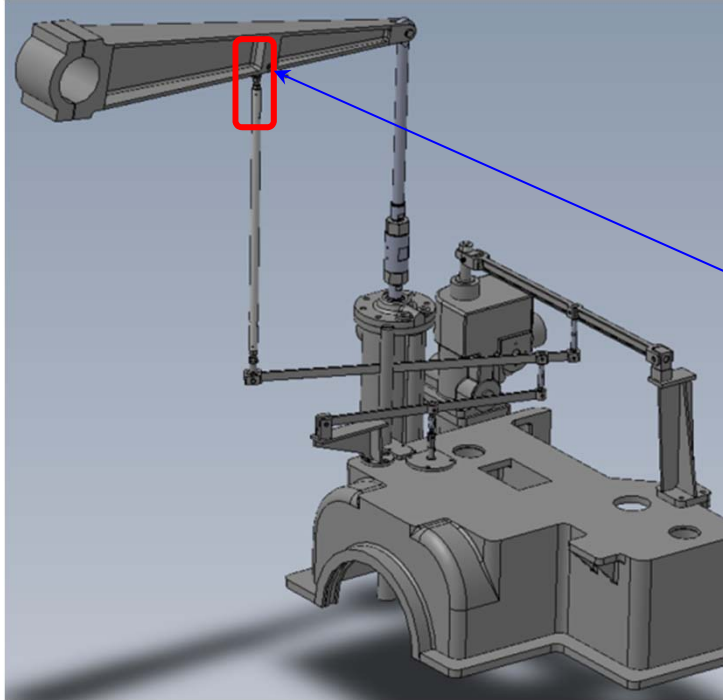
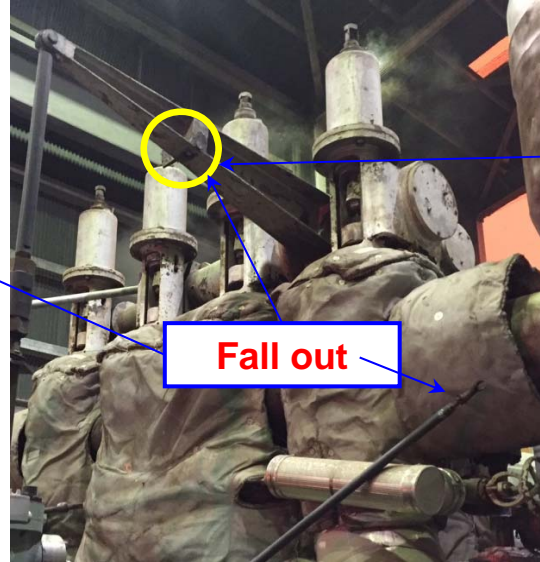
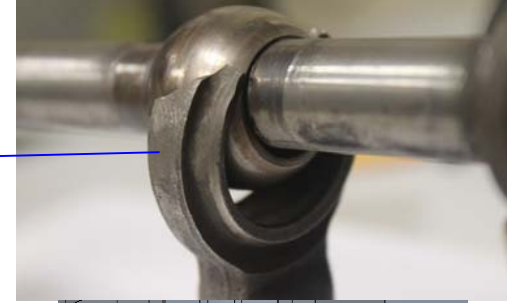
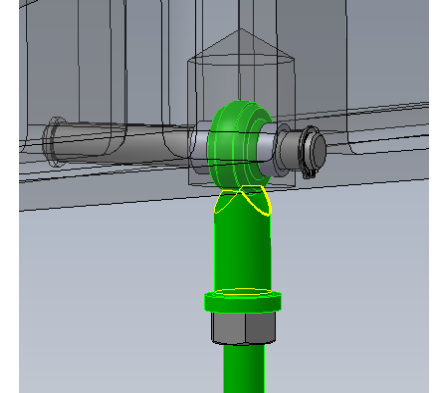
Governing Linkage Outline

The rod end bearing failure occurred after the Turbine had been in operation for **9 years**.

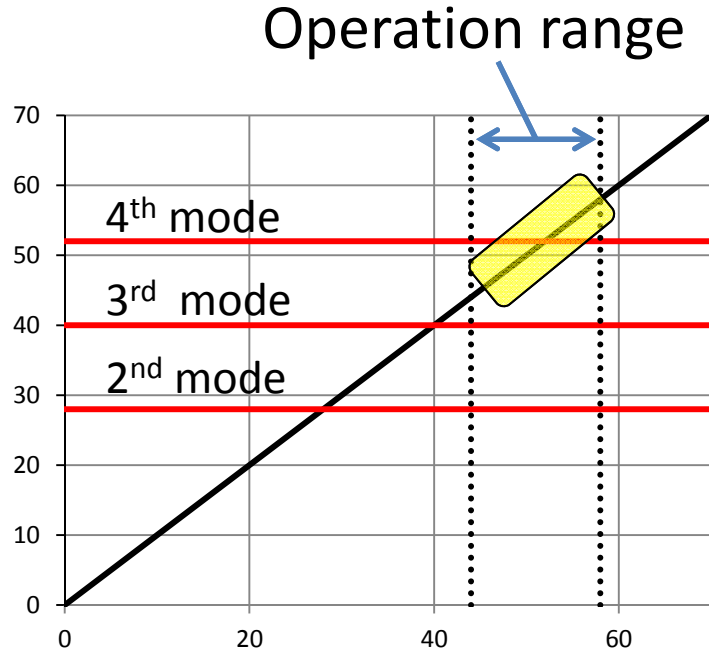
Possible Cause

Fatigue fracture pattern and vibration analysis indicated that the 4th resonance mode falls in the Turbine operation range.

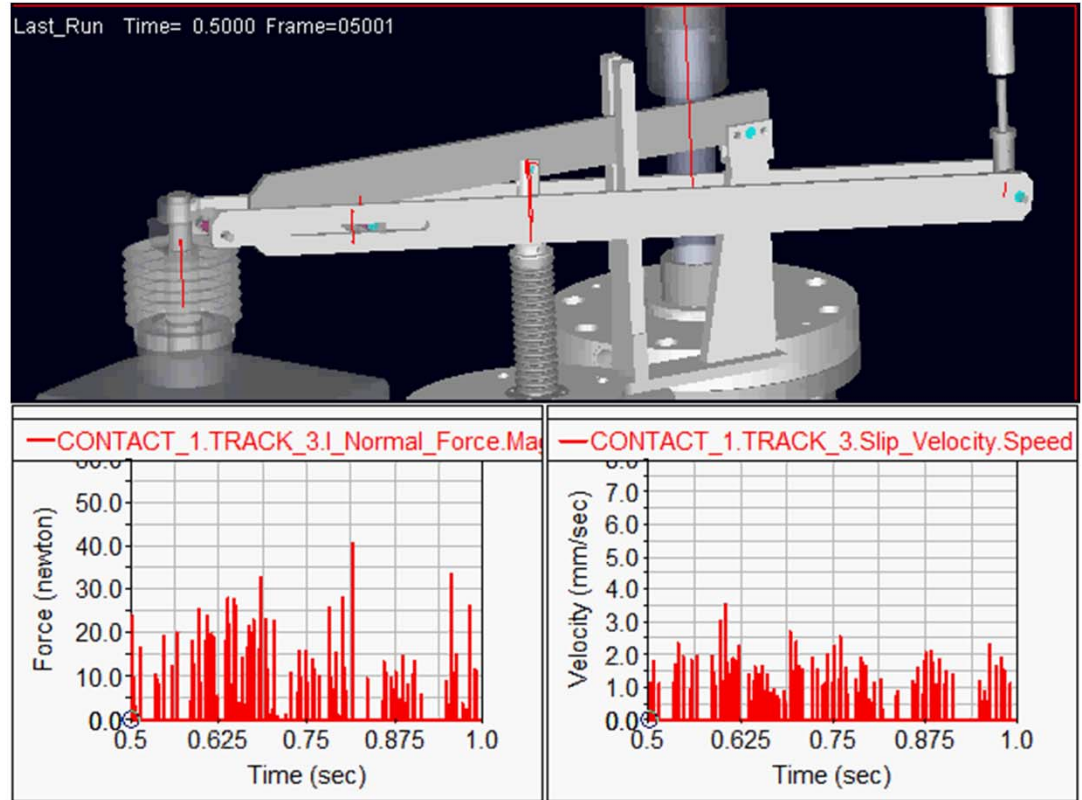
Motion Analysis

Excitation force was estimated using motion analysis with the help of static force.

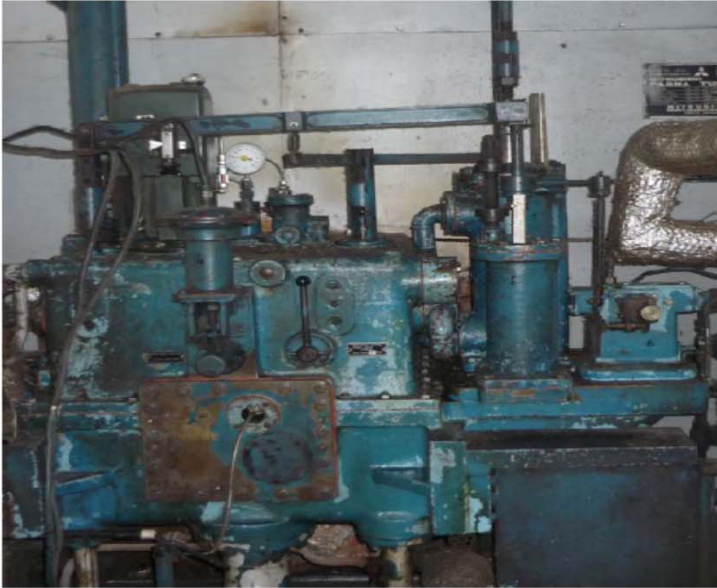
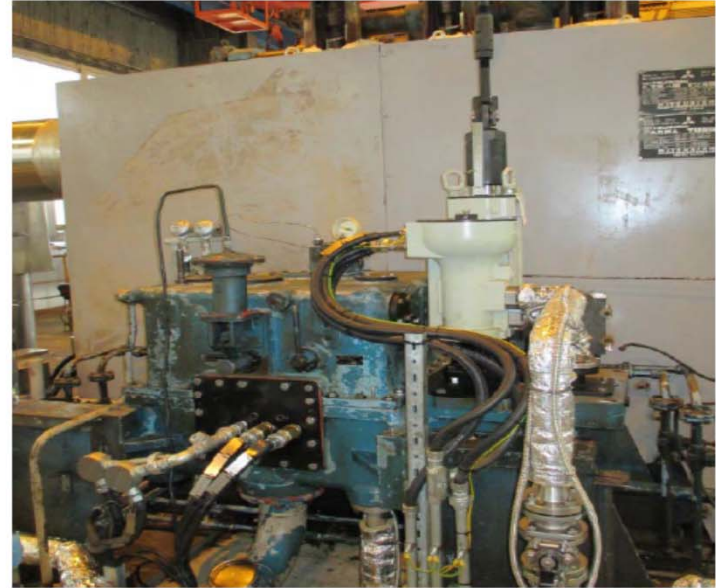
Conventional Actuator
(Before Revamp)

Direct-drive Actuator
(After Revamp)

- Plan 3: Replace with Direct-drive actuator (Linkages are minimum).
